**MULTI-MEDIA COMPLIANCE EVALUATION INSPECTION
U.S. ENVIRONMENTAL PROTECTION AGENCY
REGION III
OFFICE OF ENFORCEMENT, COMPLIANCE, & ENVIRONMENTAL JUSTICE**

**American Zinc Recycling Corporation
(formerly Horsehead Corporation)
900 Delaware Ave
Palmerton, Pennsylvania 18071**

Inspection Dates: 14-18 May 2018

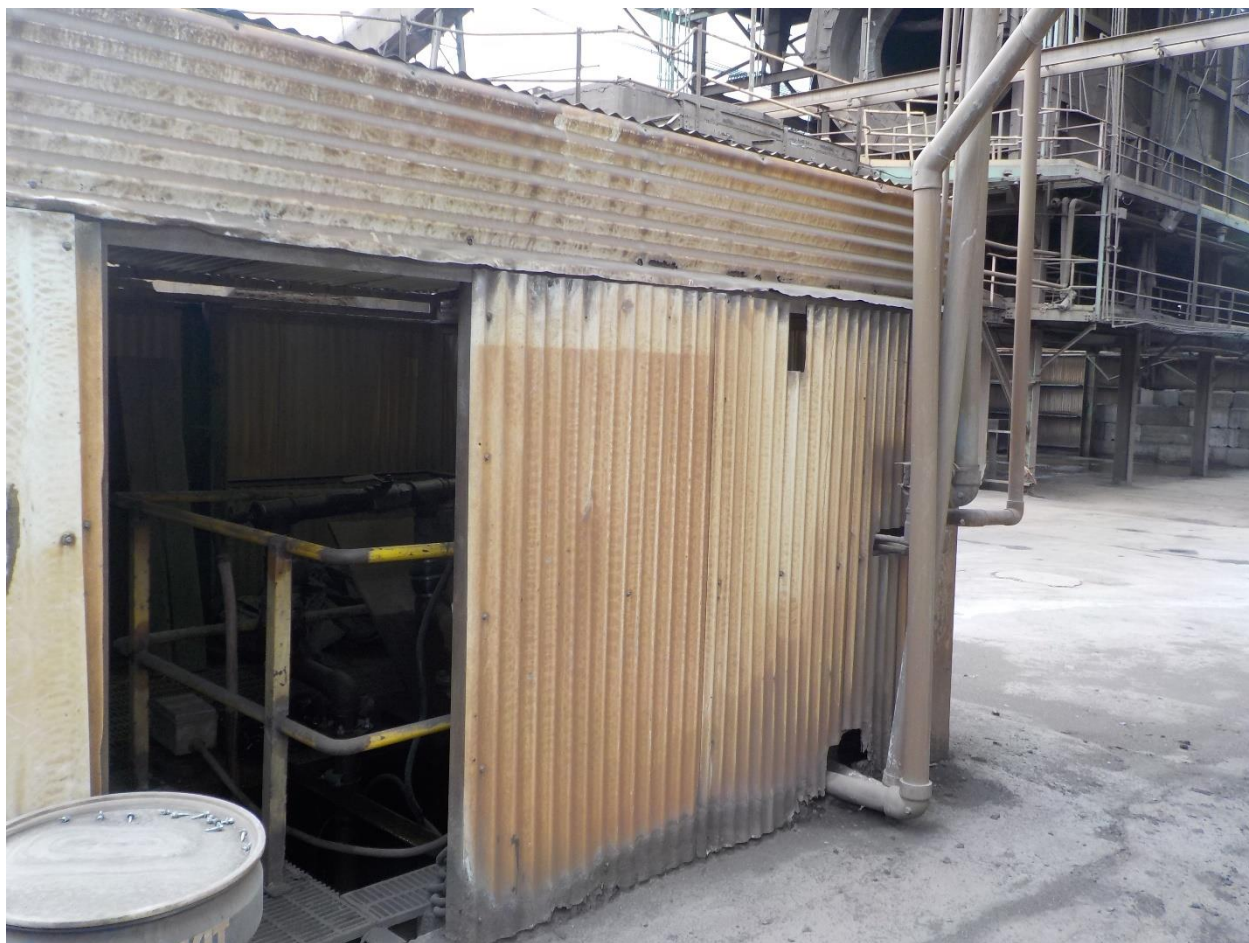
Photo 73. (DSCN0286) This photo shows the entrance to the “Pump pit” building. See also Photo 44 for a view of the “Pump pit” building with respect to Kiln 2.

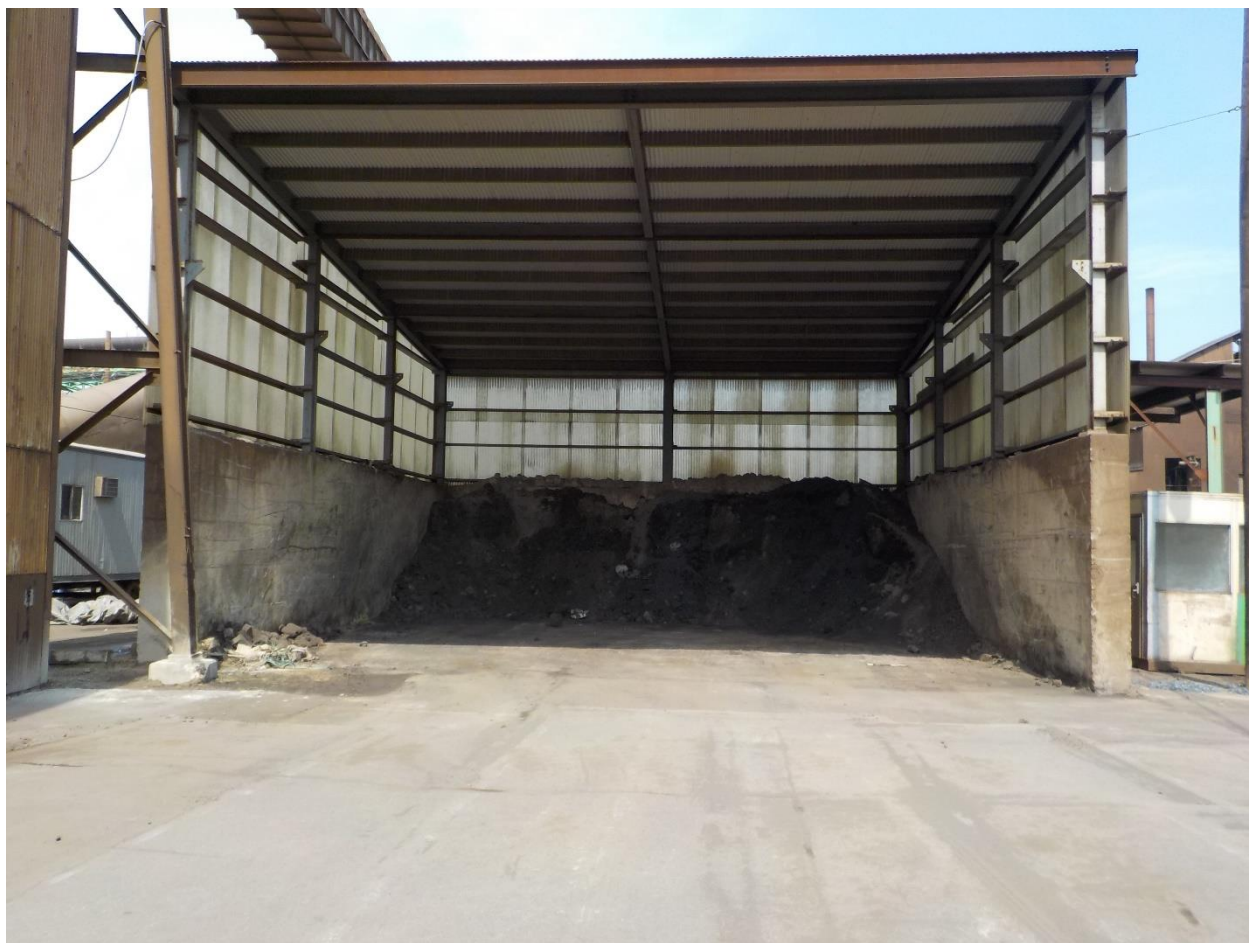
Photo 79. (DSCN0252) This photo looks eastward at the Lime bunker. Note, a pile of kiln rubble (damaged kiln brick), a D006/D008 hazardous waste, is present inside the bunker. See also Photos 33, 35, and 80.
